# Geotechnical Investigation

## Aloravita – Phases 3 and 4

67th Avenue and Jomax Road  
Peoria, Arizona  
ProTeX Job No.: 9821

Report Prepared for: Shea Homes and the Arizona State Land Department

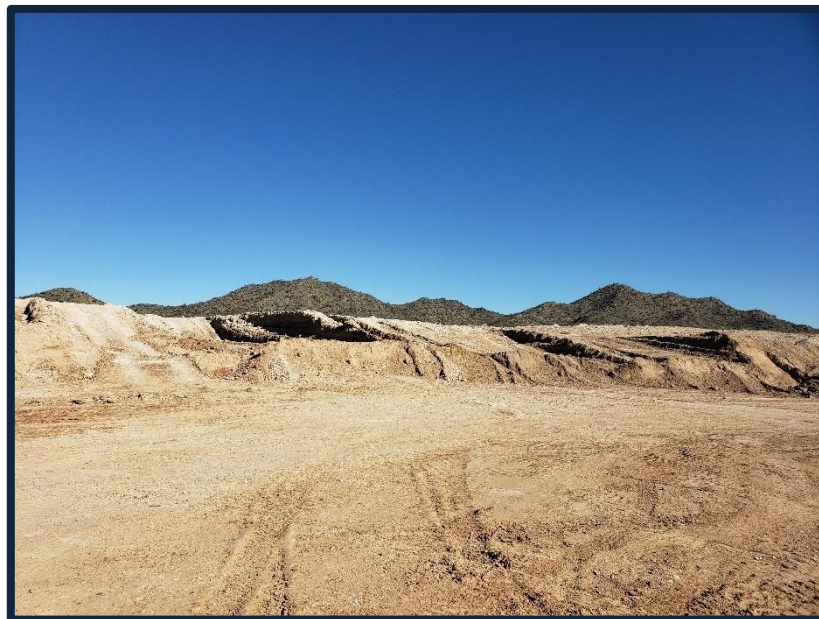
*Figure 1 - South side of the Large Stockpile*

- Rock outcrops were observed throughout the native portion of the site
- Natural washes with steep slopes were located throughout the native portion of the site
- Light to zero vegetation coverage throughout the cleared southwestern portion of the site
- Moderate native vegetation in the native portion consisting of grasses, bushes, trees and cacti.
- Previously constructed, temporary, drainage channel located in the northern portion of the cleared area
- Mountainside topography with general slope and drainage of the site trends toward the southwest
- Large soil and aggregate stockpile, created during the construction of previous phases within Aloravita development, approximately 10 to 30 feet high. Evidence of hard dig conditions was observed in the stockpile consisting of large chunks of cementation and weathered rock

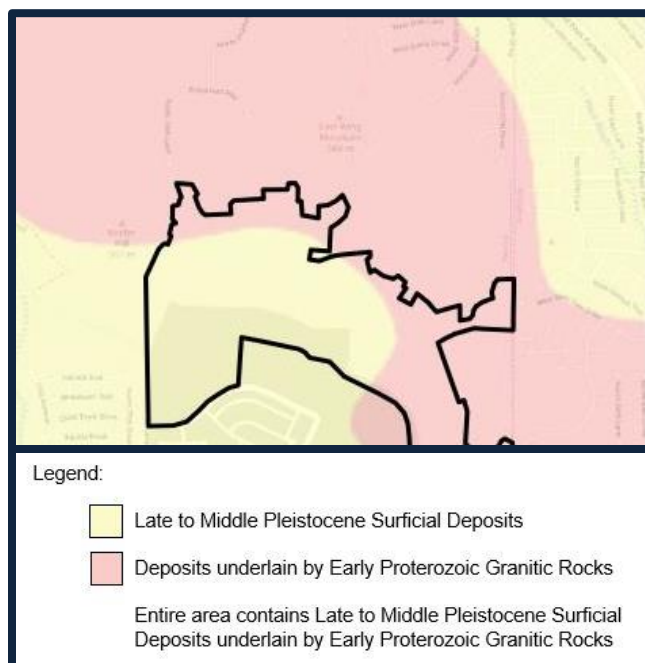
The southern portion of the site is located in an area of Late and Middle Pleistocene Surficial Deposits (10-750 ka) – unconsolidated to weakly consolidated alluvial fan, terrace, and basin-floor deposits with moderate to strong soil development. Fan and terrace deposits are primarily poorly sorted, moderately bedded gravel and sand, and basin floor deposits are primarily sand, silt and clay. The northern and eastern portions of the site are located in an area of Early Proterozoic Granitic Rocks (1600-1800 Ma) – which can contain a wide

variety of granitic rocks, including granite, granodiorite, tonalite, quartz diorite, diorite, and gabbro. These rocks commonly are characterized by steep, northeast-striking foliation.

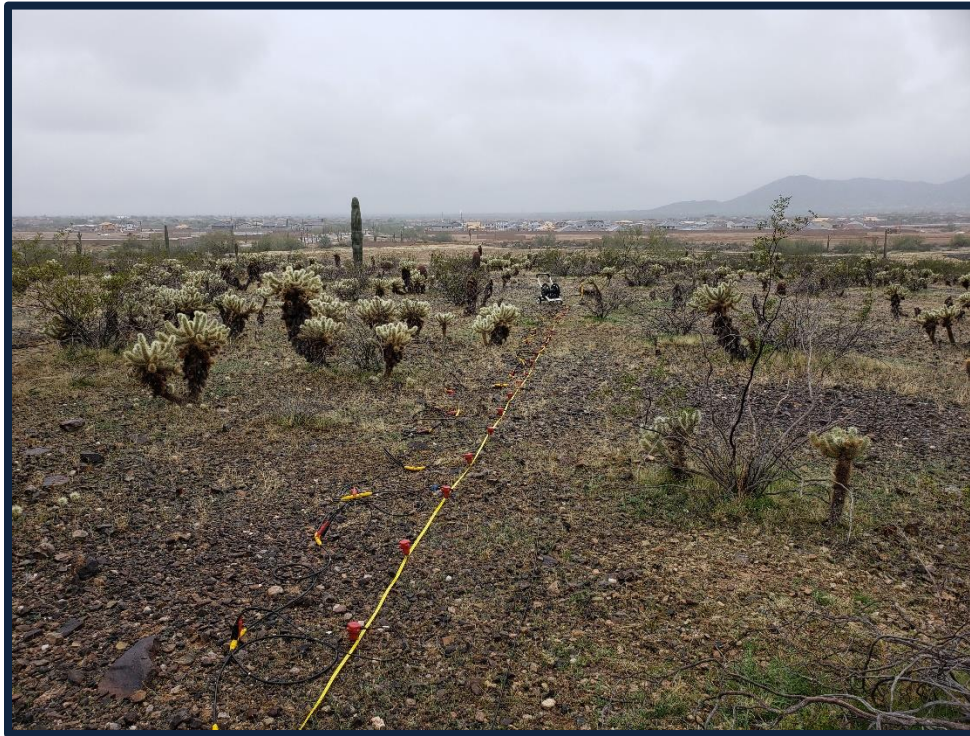
*Figure 3 - Typical Seismic Refraction Line*

The seismic refraction survey consists of introducing a sound pulse into the ground and recording the time of first arrival vibrations at different horizontal distances. The sound pulse is most often generated by manually striking a steel plate/ball with a sledge hammer but can also be generated by small explosions. For the purpose of this survey a sledge hammer was utilized. The sound is recorded on an engineering seismograph utilizing one or more sound vibration detection devices known as

geophones. The seismic refraction survey is interpreted to indicate a subsurface profile consisting of three consistent and distinct subsurface strata described below (See Appendix D for individual seismic line profiles):

**Layer 1:** This uppermost surficial layer (layer 1) has an average velocity of 1750 feet per second (fps) in a range from 1000 to 2500 fps. The layer thickness and depth from existing site surface grade varies from about 1 to 15 feet and likely represents a sandy soil, clayey sandy soil and clayey soil with various amounts of gravel and cobbles. Layer 1 exists to an average depth of 3.5 feet below the existing site surface at the locations of the seismic survey.

**Layer 2:** An intermediate layer (Layer 2) that has an average velocity of 3750 fps within a range from 2500 to 5000 fps. This layer extends from the base of the surficial layer and was encountered at depths ranging from 1 to 15 feet below existing site surface grades. The intermediate layer thickness likely represents a zone of very highly to highly weathered rock and/or possible

moderately cemented soils with gravels and cobbles. Layer 2 exists below an average depth of 3.5 feet below existing site surface at the locations of the seismic survey lines.

**Layer 3:** A bottom layer (Layer 3) that interfaces with the base of Layer 2 and has an average velocity of 6500 fps within a range of 5000 fps to 8000 fps. This layer extends from the base of the surficial layer and was encountered at depths ranging from 3 to 15 feet below existing site surface grades. Layer 3 likely represents highly to moderate weather rock and/or possible strongly cemented soils with gravels and cobbles. Layer 3 exists below an average depth of 11.5 feet below existing site surface at the locations of the seismic survey lines.

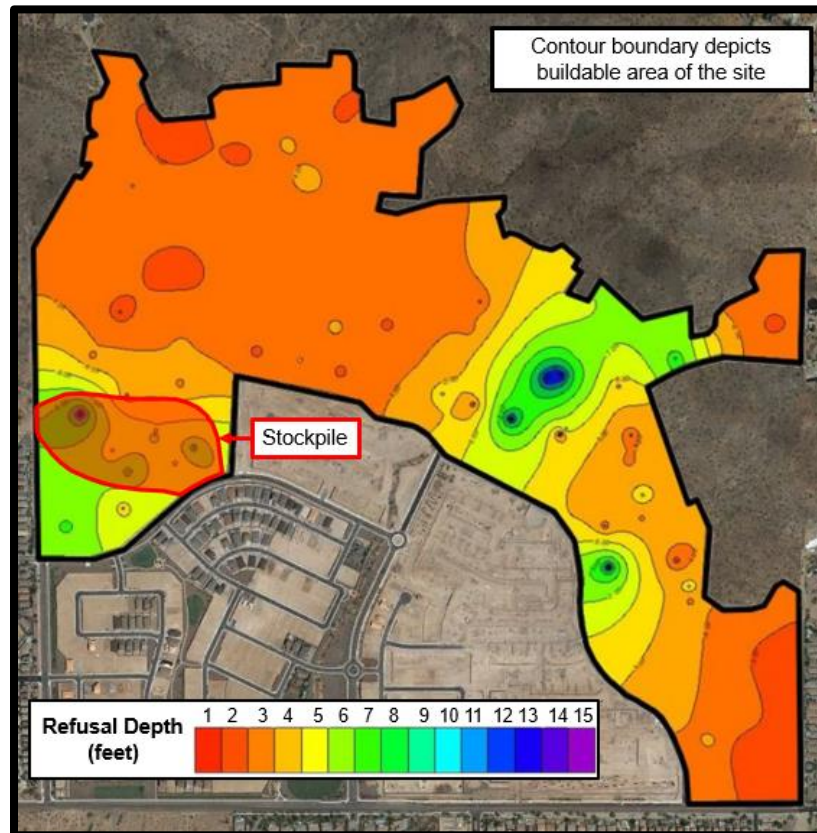
The depths of the various weathered rock formation are highly variable at the site as indicated by seismic refraction survey profiles and observed areas of rock outcropping. See the figure below for the refusal depth contour map for anticipated depth to refusal based on the drilled test holes, backhoe test pits and seismic refraction survey. The contour map below represents the anticipated

depth to hard dig (alternative excavation) conditions within the boundaries of the anticipated buildable area.

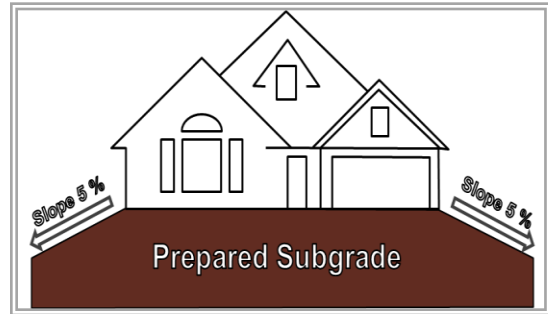
*Establishment and long term maintenance of proper lot post-construction surface drainage is critical.* Because of the potential for an adverse effect on structures, it is highly recommended that moisture infiltration and fluctuation of bearing soils for structural foundation/floor be minimized. Roof runoff should be collected and discharged away from the house structures. Drainage of surface water away from the structures should be provided during construction and maintained by the homeowner throughout the life of the structure. In no case, should long-term ponding be allowed near house structures. IRC Section R401.3 specifically requires “The grade away from the foundation walls shall fall a minimum of 6 inches within the first 10 feet. Where lot lines, walls, slopes or other physical barriers prohibit 6 inches of fall within 10 feet, drains or swales shall be provided to ensure drainage away from the house structure”. Thus, un-drained landscape “islands” bounded by concrete flatwork and/or foundation wall/slab elements are to be avoided. Installation of rain gutters along the perimeter of the residential structure with drain systems to transport water away from the foundation and to the outfall of the lot is an option to minimize moisture infiltration and fluctuation of bearing soils for structural foundation/floor systems.

In yard areas, it is suggested that, where possible, finished slopes extend a minimum of 10 feet horizontally from building walls and have a minimum vertical fall of 6 inches. Backfill against footings, exterior walls and in utility trenches should be compacted to minimize the possibility of moisture infiltration through loose soil.

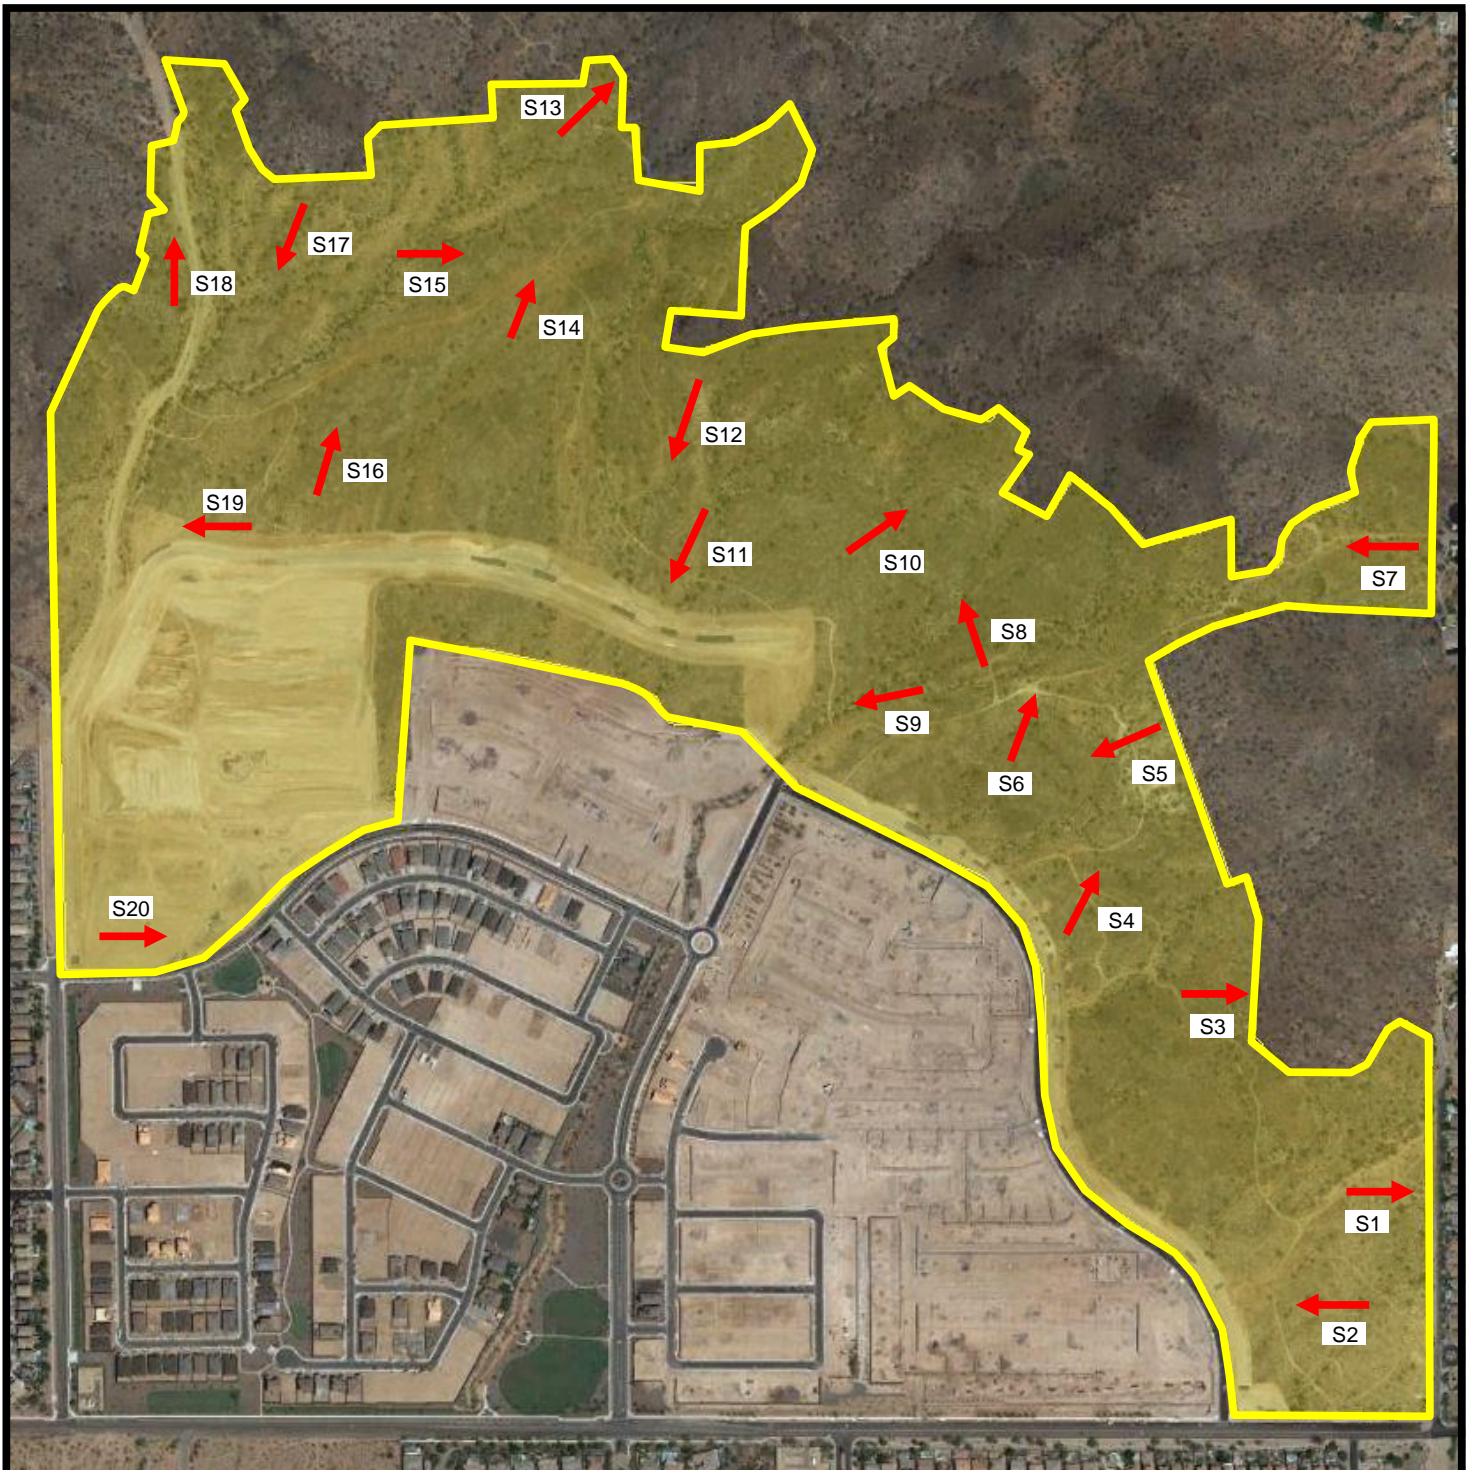
→ Approximate Seismic Refraction Line

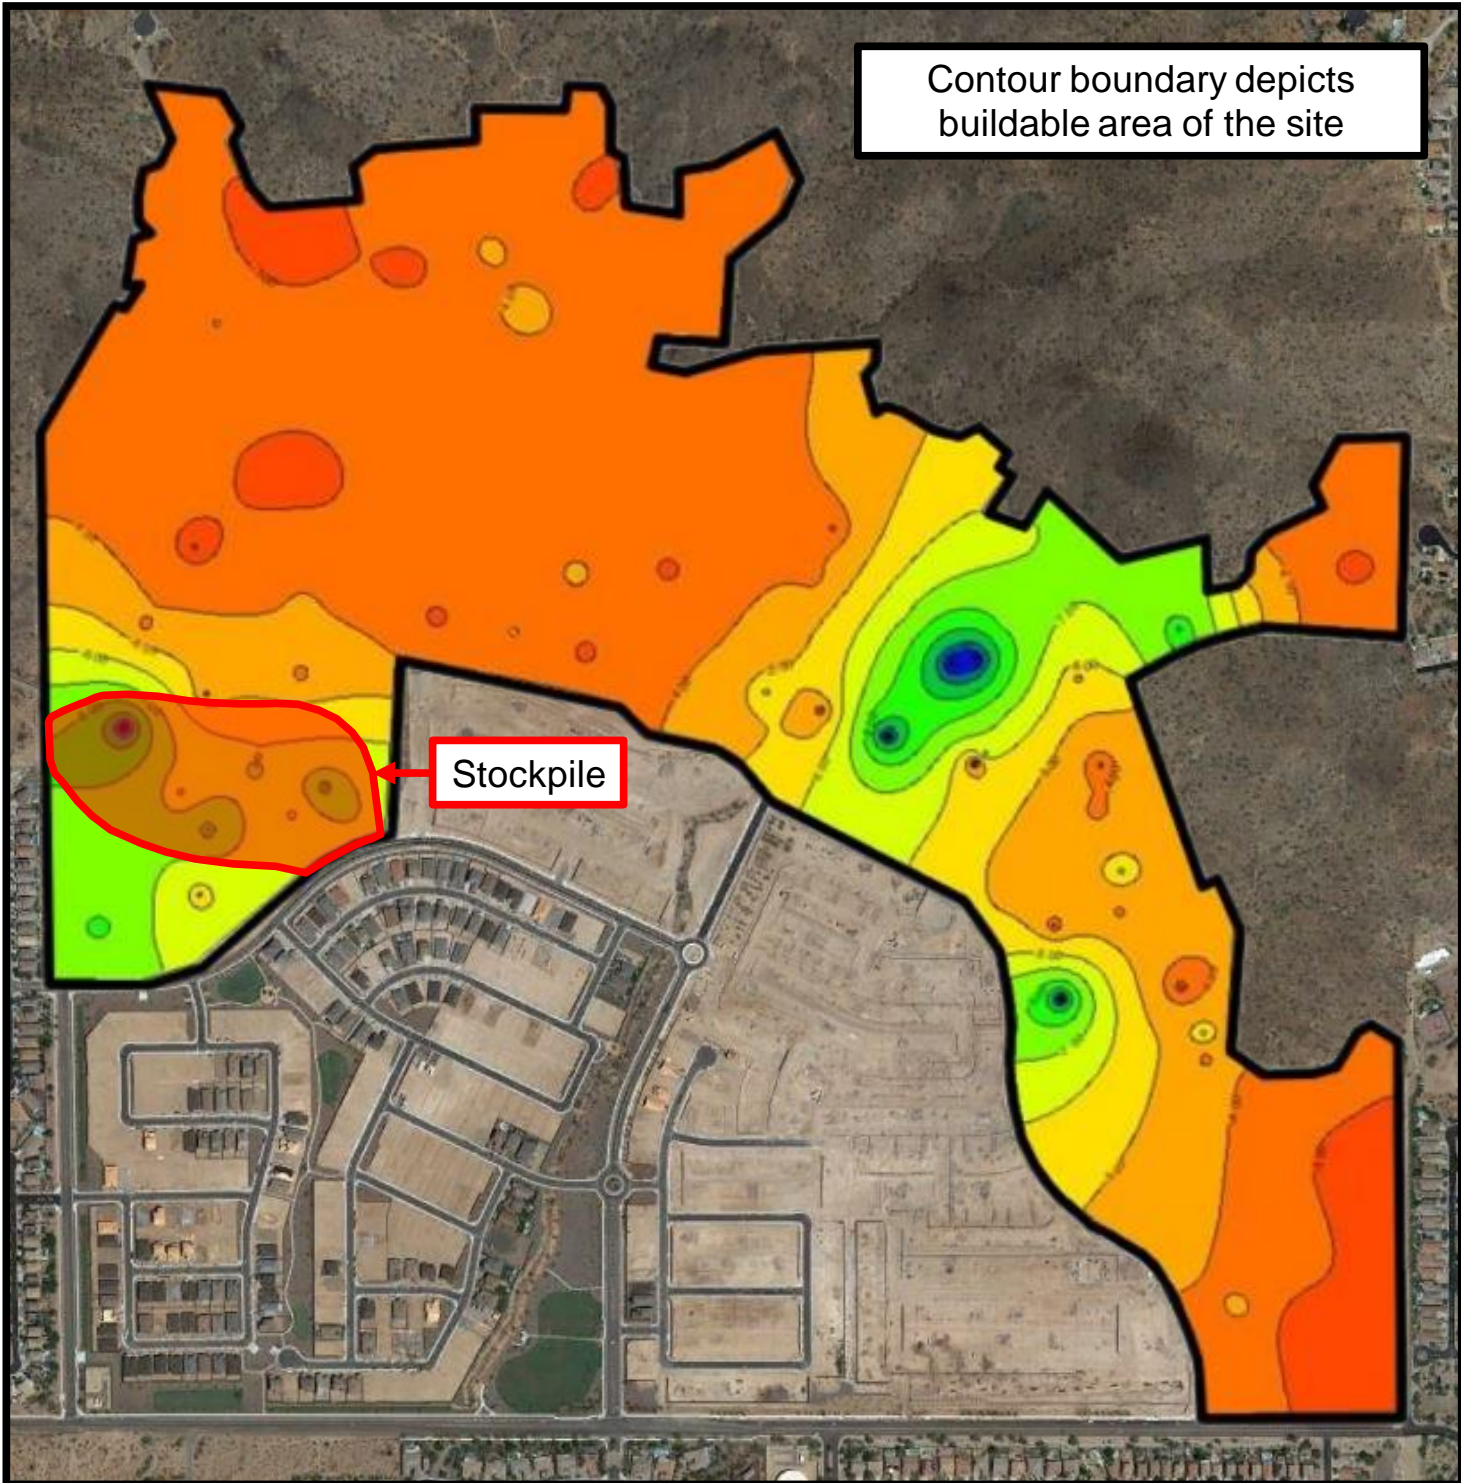
Contour boundary depicts  
buildable area of the site

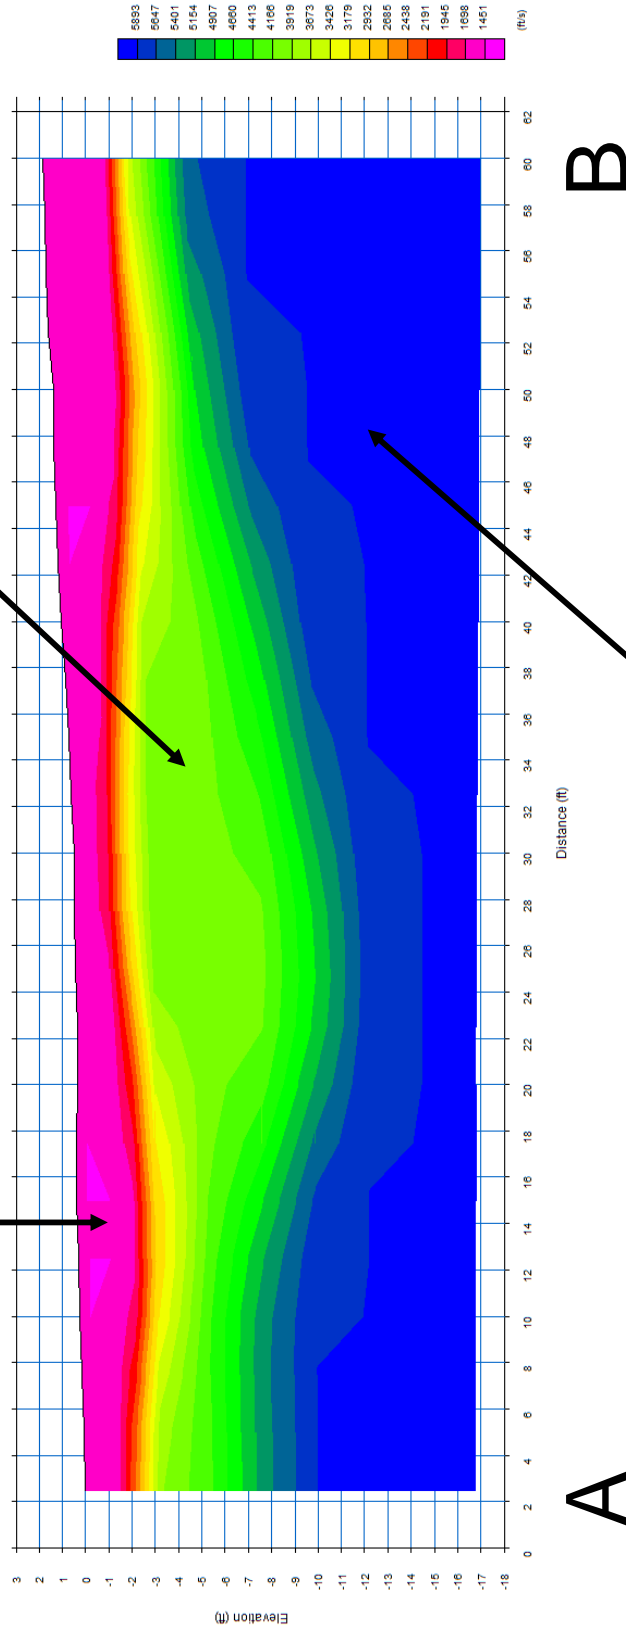
## Seismic Line #1

**Layer 3**  
 Granitic Rock; Moderately Weathered  
 Rock/Decomposed Granite  
 Vp = 5000 - 8000 fps

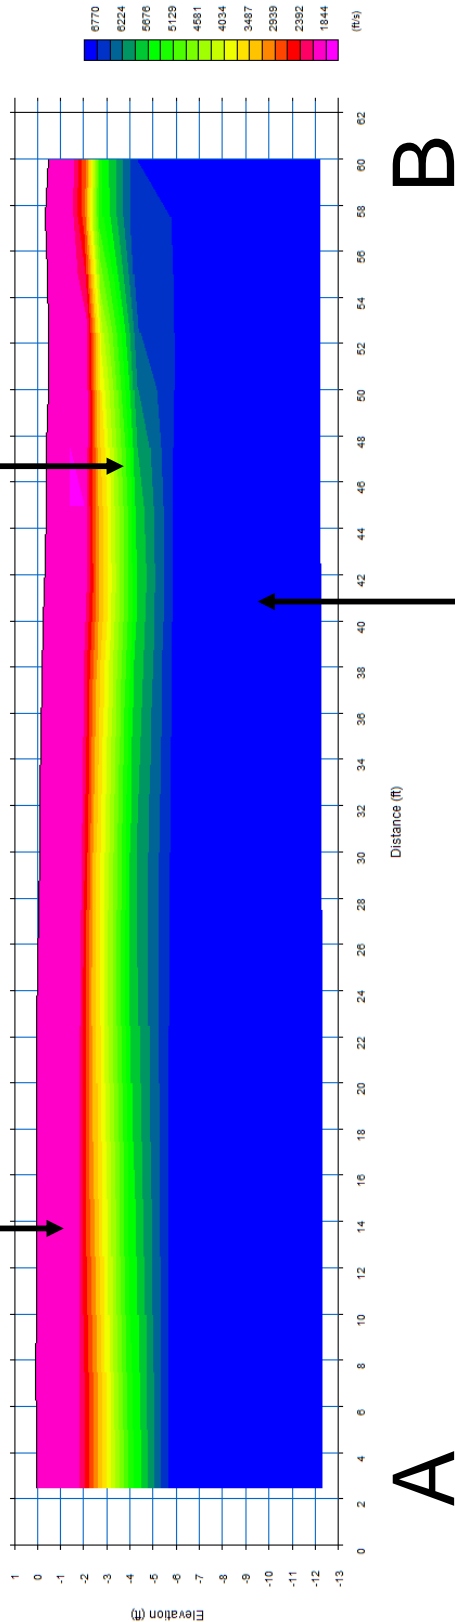
## Seismic Line #2

**Layer 3**  
 Granitic Rock; Moderately Weathered  
 Rock/Decomposed Granite  
 Vp = 5000 - 8000 fps

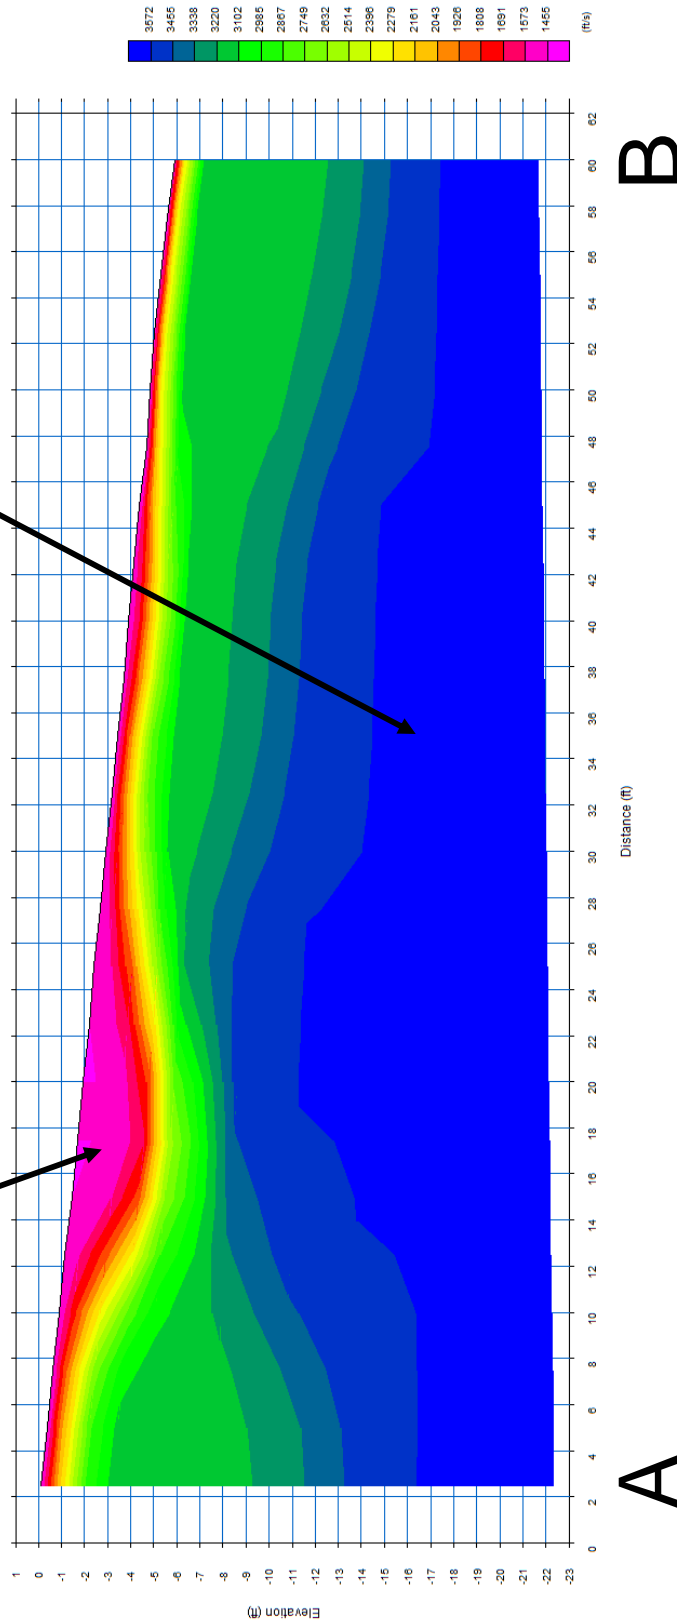
## Seismic Line #3

Surficial Layer of Silty Sand and  
Clayey Sand Soils with Varying  
Amounts of Gravel  
Vp = 1000 - 2500 fps

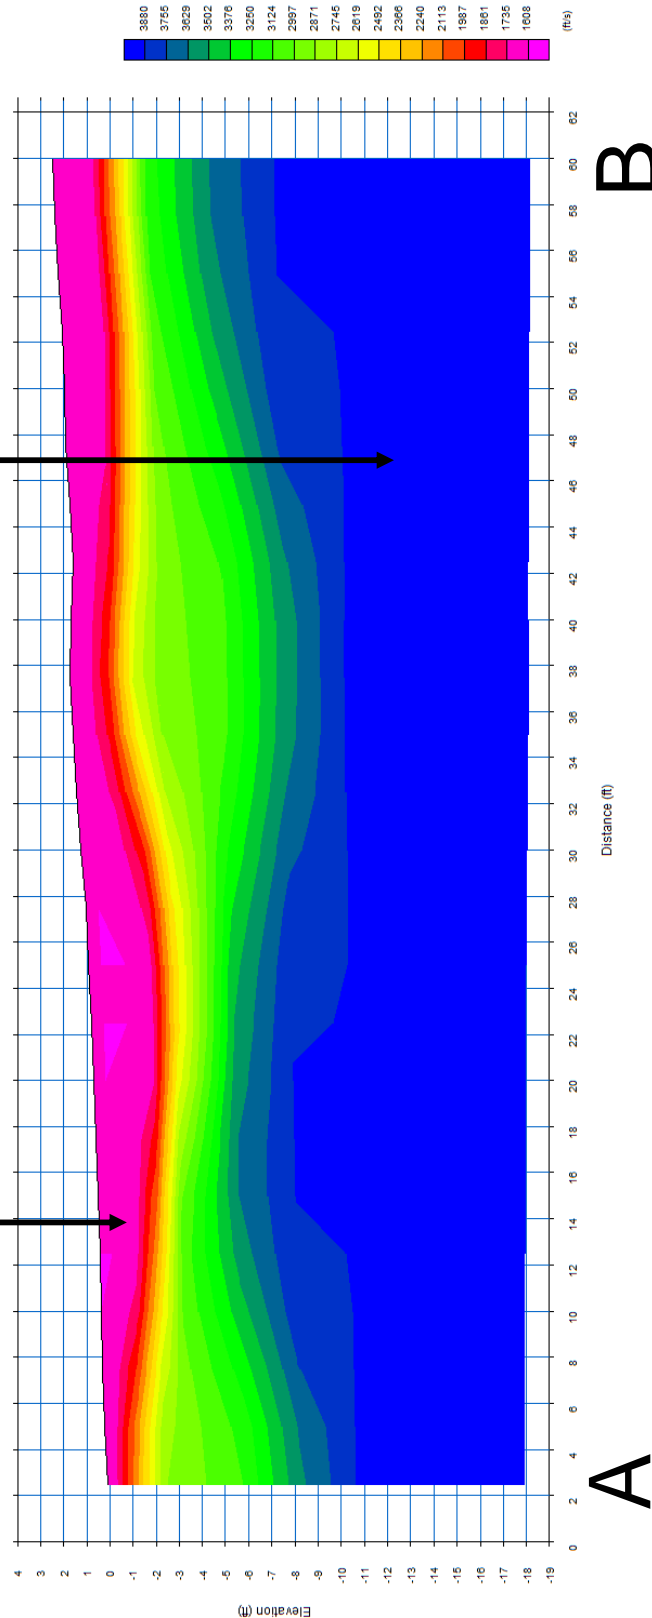
## Seismic Line #4

Granitic Rock; Very Highly to Highly Weathered  
Rock/Decomposed Granite, Possible Cementation  
and Dense Gravel and Cobbles  
Vp = 2500 - 5000 fps

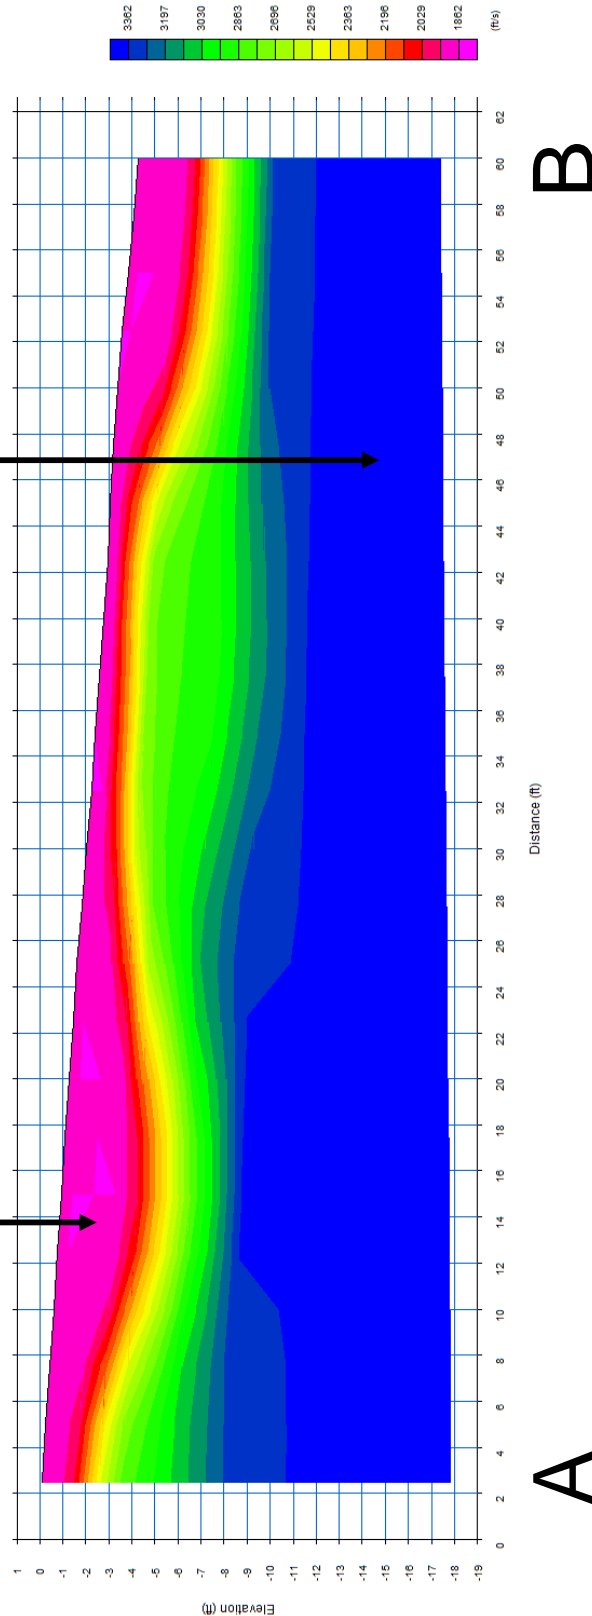
## Seismic Line #5

Granitic Rock; Very Highly to Highly Weathered  
Rock/Decomposed Granite, Possible Cementation  
and Dense Gravel and Cobbles  
Vp = 2500 - 5000 fps

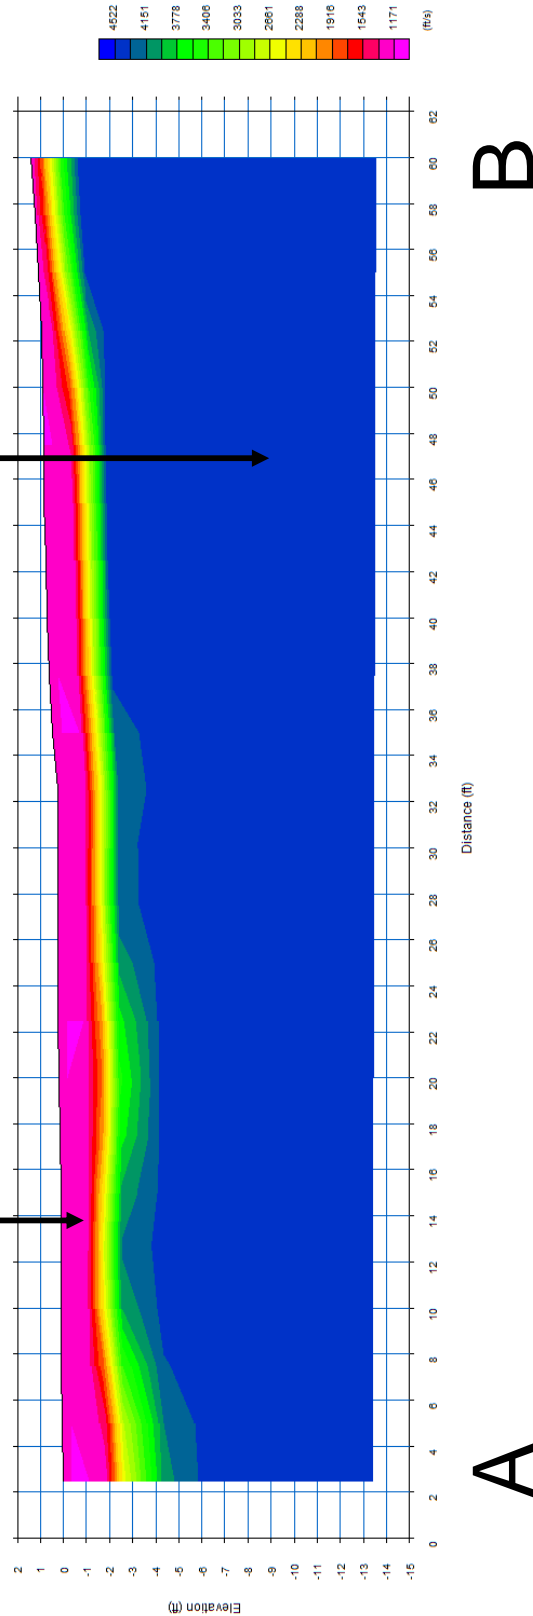
## Seismic Line #6

Surficial Layer of Silty Sand and  
Clayey Sand Soils with Varying  
Amounts of Gravel  
Vp = 1000 - 2500 fps

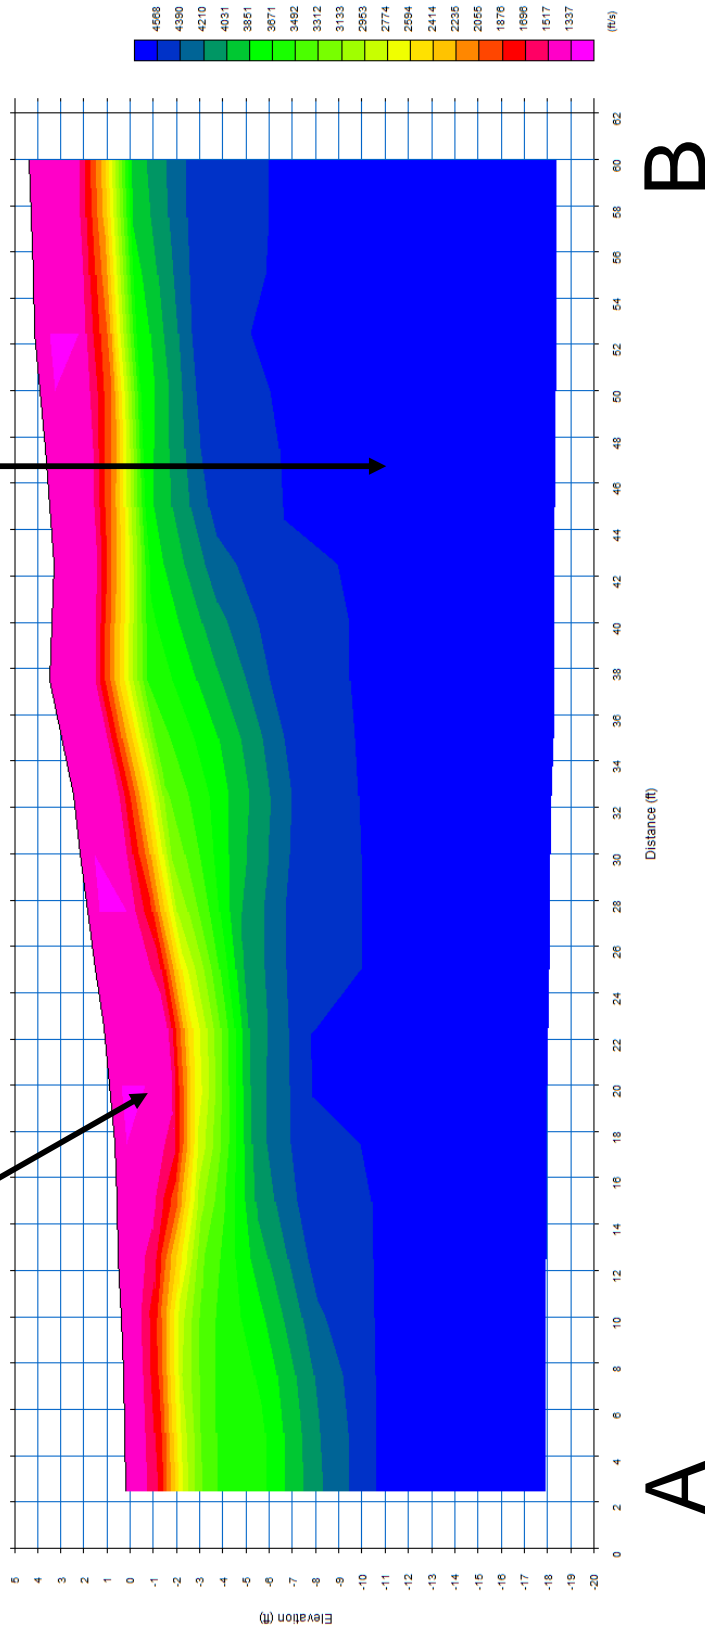
## Seismic Line #7

**Layer 1**  
Surficial Layer of Silty Sand and  
Clayey Sand Soils with Varying  
Amounts of Gravel  
Vp = 1000 - 2500 fps

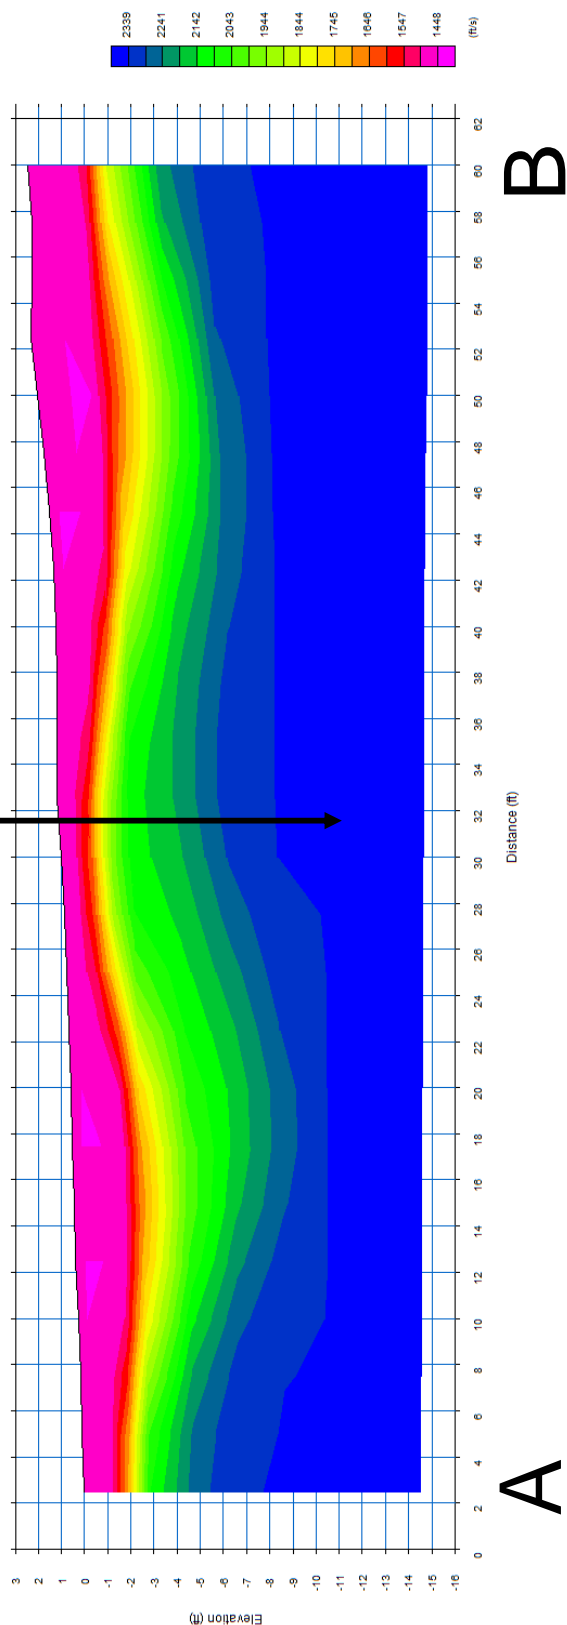
## Seismic Line #8

**Layer 1**  
**Surficial Layer of Silty Sand and**  
**Clayey Sand Soils with Varying**  
**Amounts of Gravel**  
 **$V_p = 1000 - 2500$  fps**

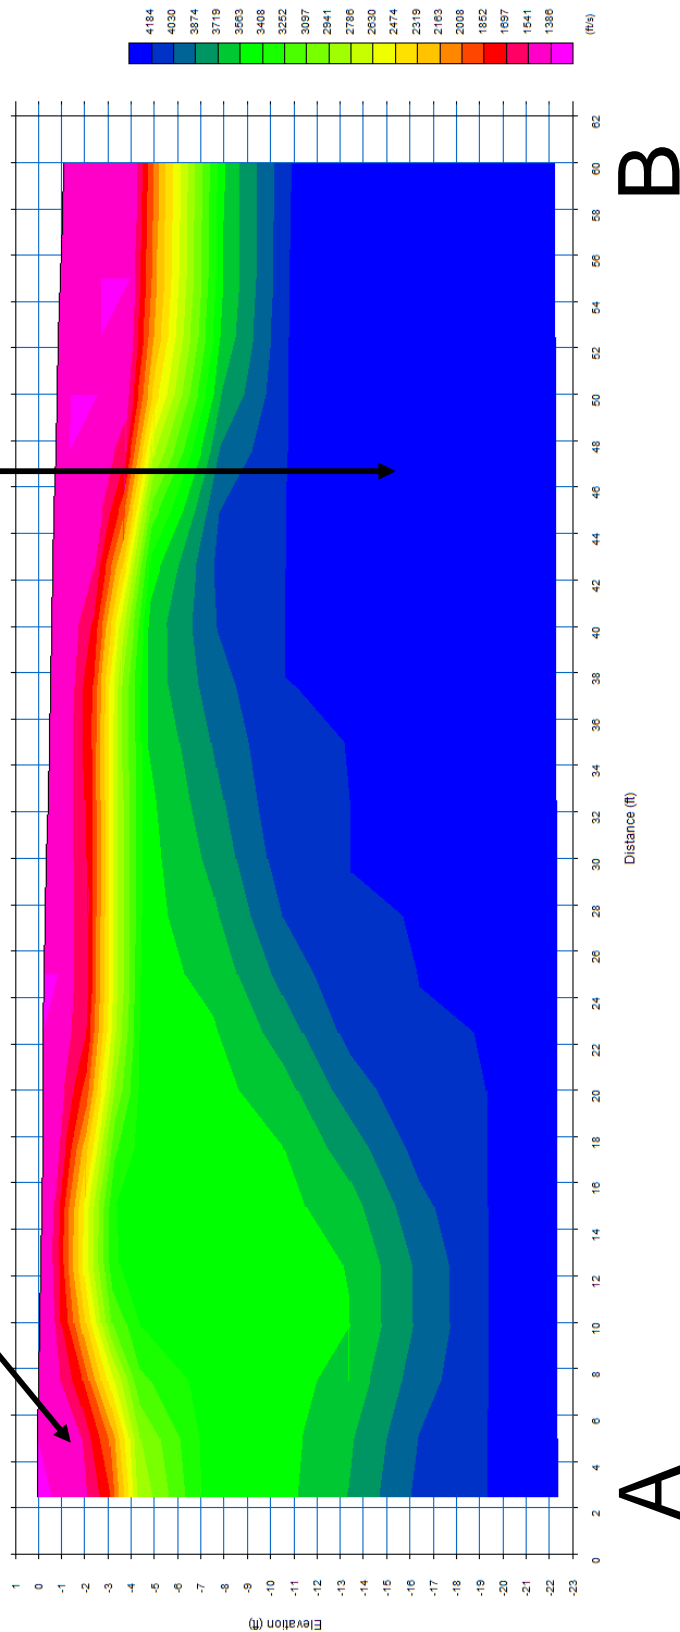
## Seismic Line #9

**Layer 1**  
Surficial Layer of Silty Sand and  
Clayey Sand Soils with Varying  
Amounts of Gravel  
Vp = 1000 - 2500 fps

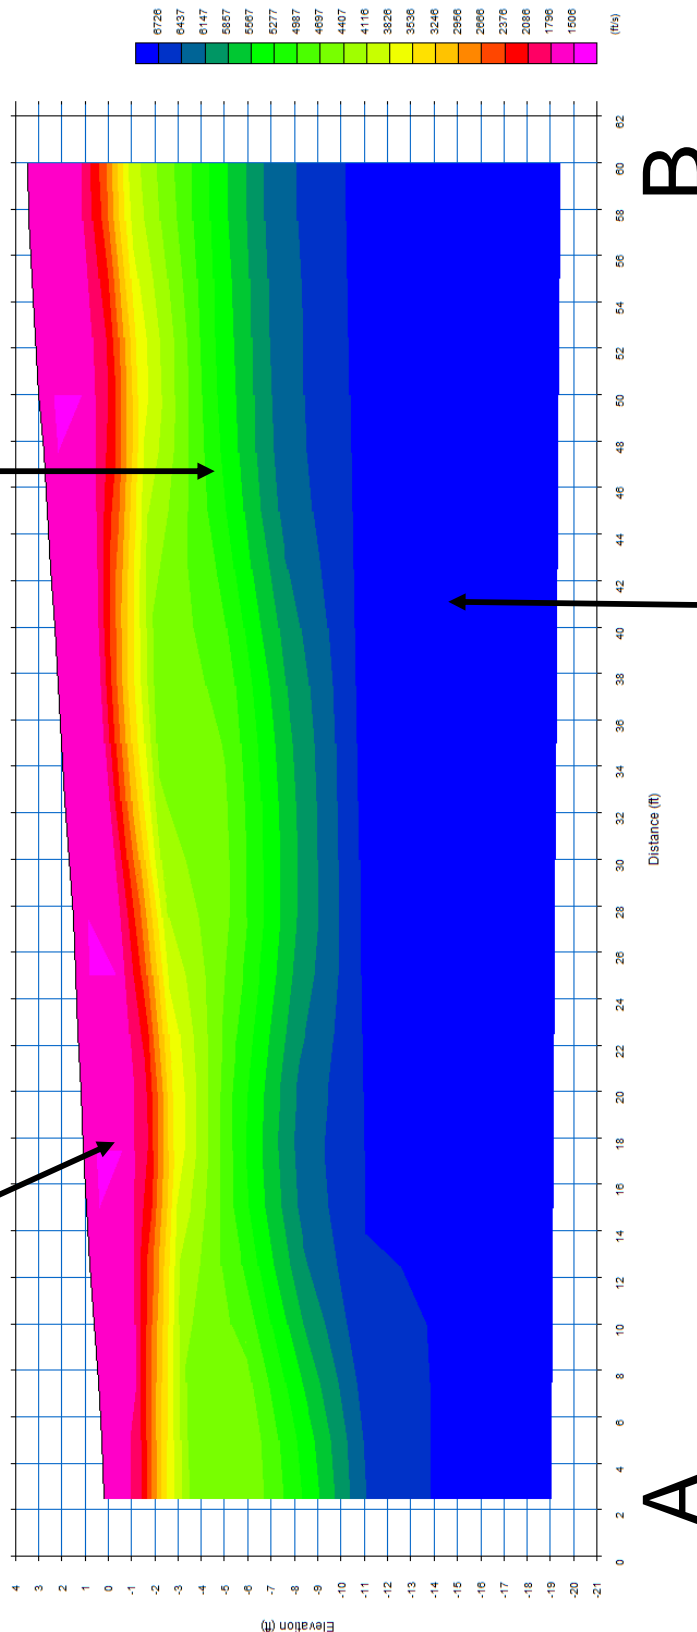
## Seismic Line #10

Granitic Rock; Moderately Weathered  
Rock/Decomposed Granite  
Vp = 5000 - 8000 fps

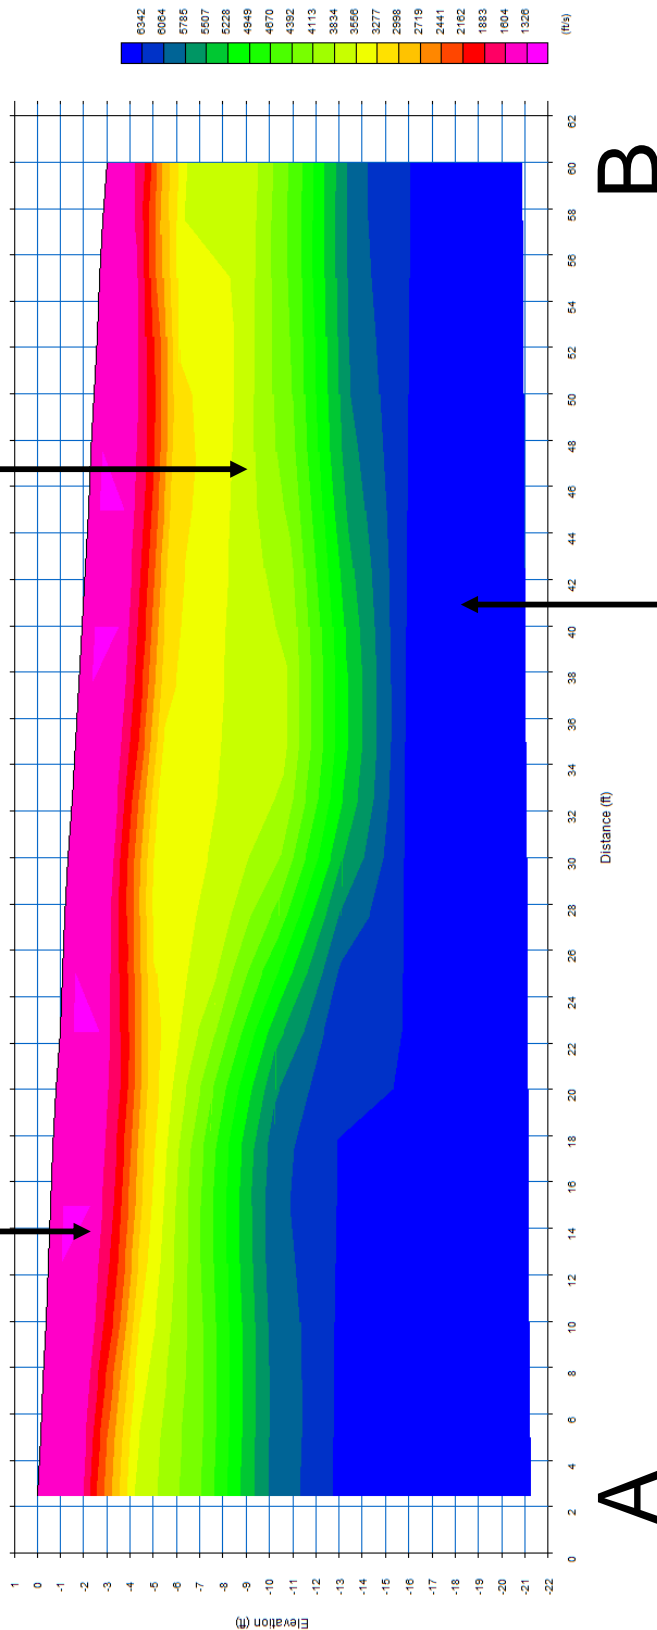
## Seismic Line #11

**Layer 3**  
 Granitic Rock; Moderately Weathered  
 Rock/Decomposed Granite  
 Vp = 5000 - 8000 fps

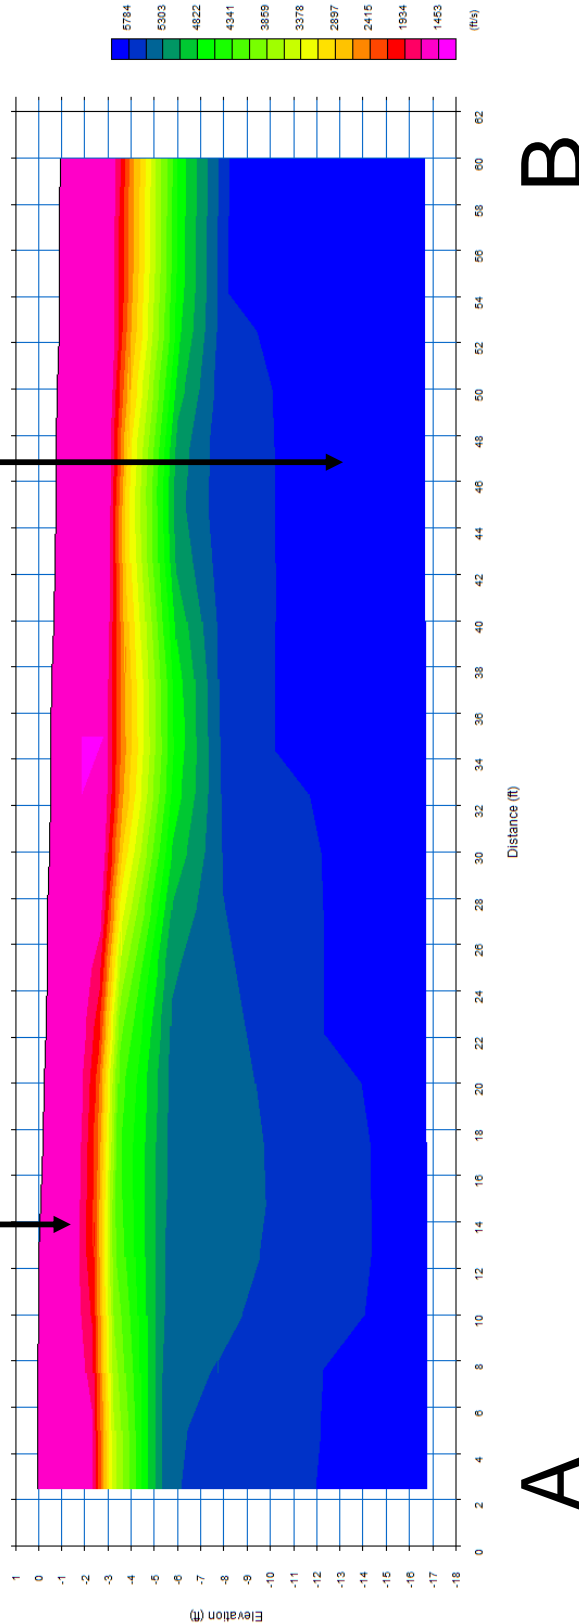
## Seismic Line #12

**Layer 1**  
 Surficial Layer of Silty Sand and  
 Clayey Sand Soils with Varying  
 Amounts of Gravel  
 Vp = 1000 - 2500 fps

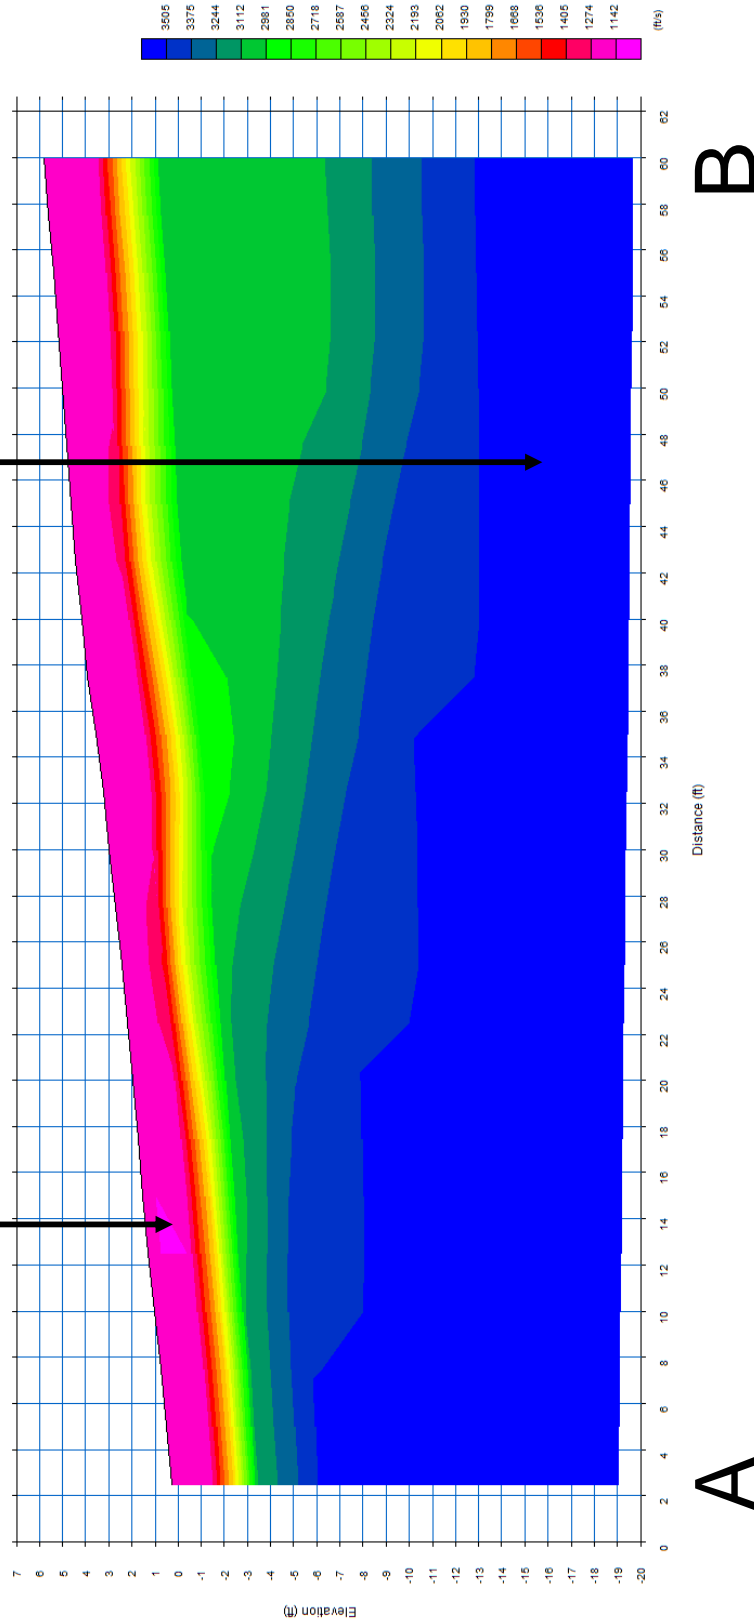
## Seismic Line #13

Granitic Rock; Very Highly to Highly Weathered  
Rock/Decomposed Granite, Possible Cementation  
and Dense Gravel and Cobbles  
Vp = 2500 - 5000 fps
